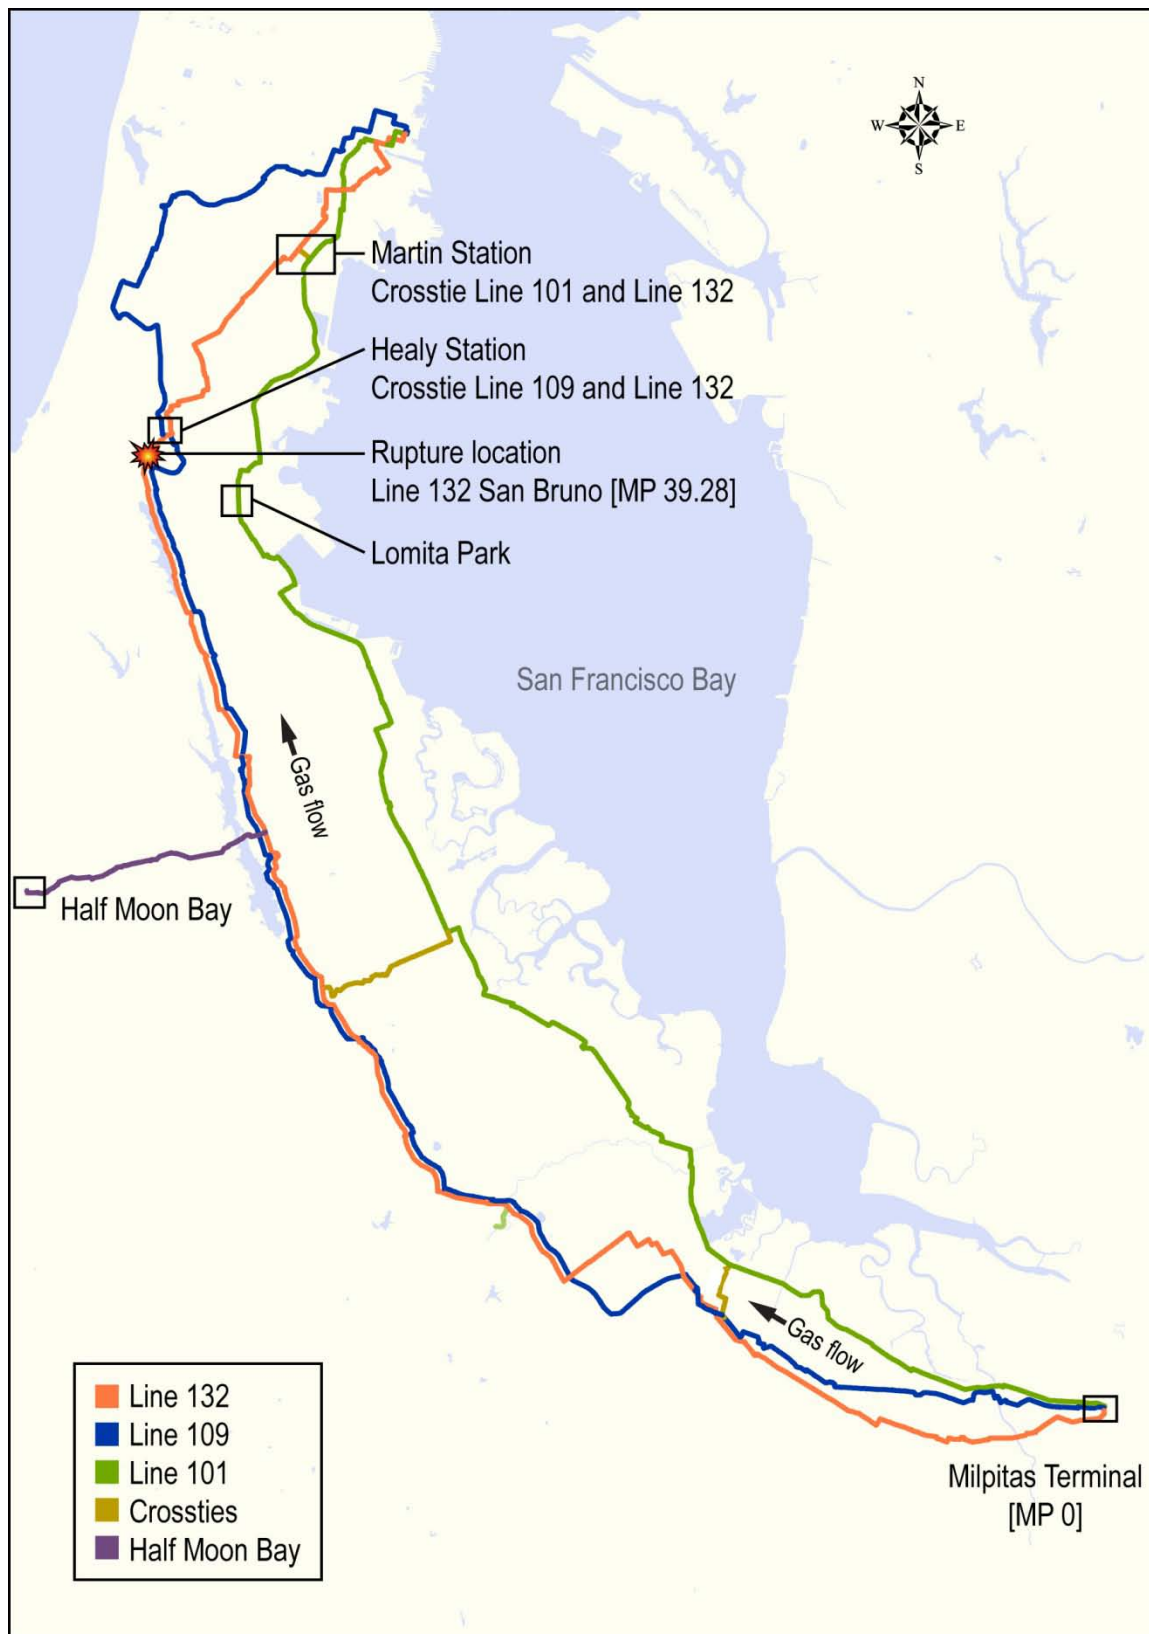
Figure 14. Map showing PG&E peninsula gas transmission lines.

Line 132 originates at the Milpitas Terminal and extends north about 46 miles to the Martin Station.³⁹ (See figure 14.) Line 132 is one of three gas transmission lines in the PG&E peninsula system. The other two are Lines 101 and 109. In all three lines, gas flow is typically from south to north. The peninsula system includes six crossties that connect the three transmission lines and allow gas to flow between them. (Four of those crossties are shown on figure 14; the two not shown connect Lines 132 and 109 at MPs 29.06 and 31.93.)

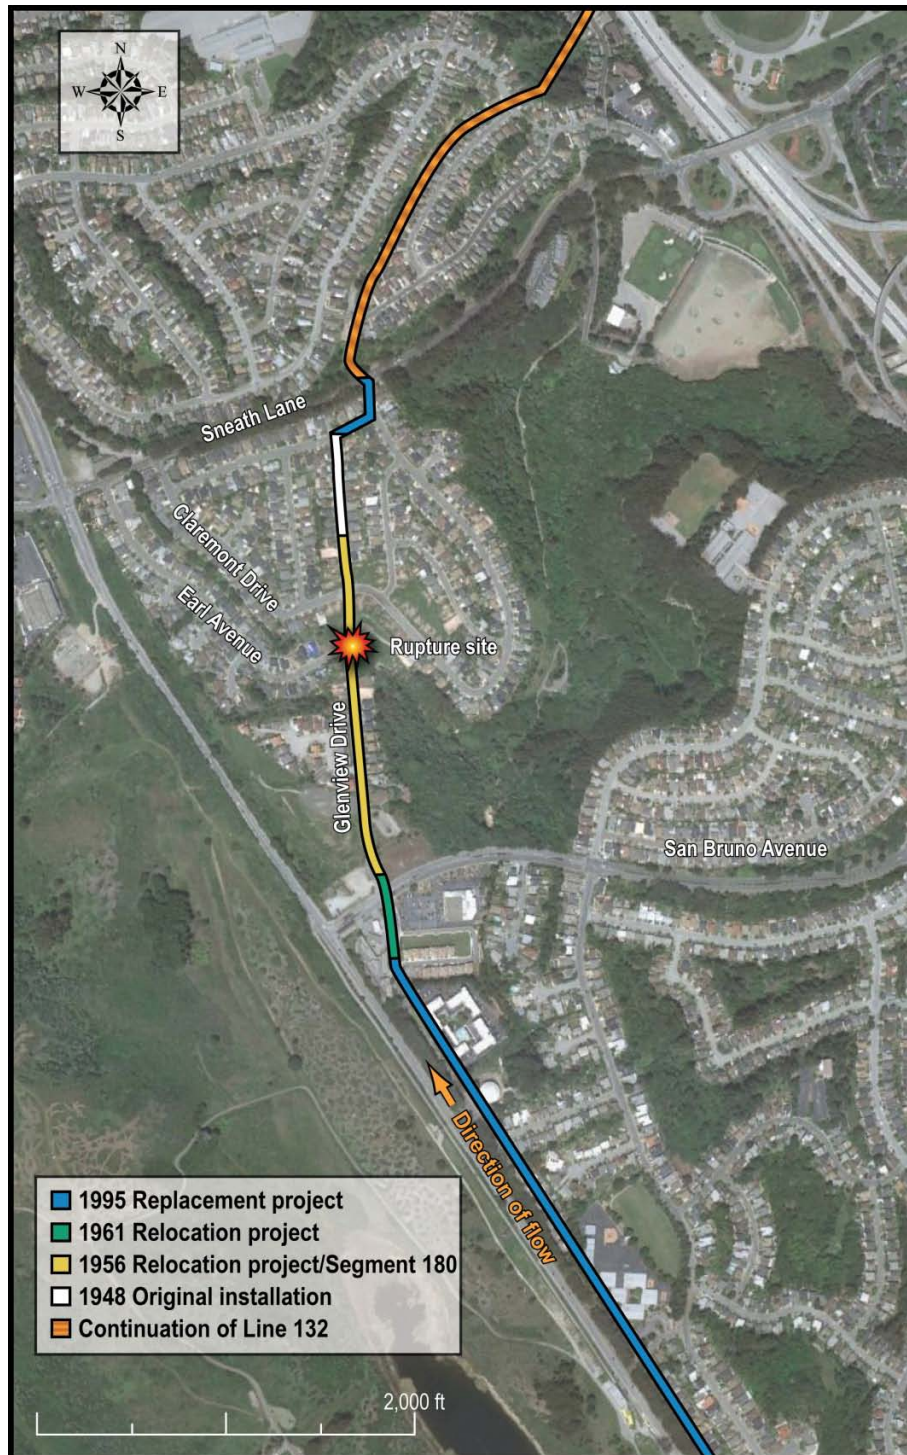
Figure 15. Line 132 installation, relocations, and replacements.

In 1956, PG&E relocated 1,851 feet of Line 132 that had originally been installed in 1948. The relocation was necessary because the existing elevation of Line 132 was incompatible with land grading that had been done in connection with residential housing being built at that location. This relocation, which included the installation of the pipe at the accident location, started north of Claremont Drive and extended south to San Bruno Avenue, and rerouted Line 132 from the east side to the west side of Glenview Drive. (See figure 15.) The relocation work was not contracted out, but rather was performed by PG&E construction crews. Construction documentation provided to the NTSB consisted of about 300 pages of journal vouchers, material transfers, paving receipts, and various other cost accounting sheets. PG&E did

In 1961, PG&E completed a second relocation project on a portion of Line 132 immediately to the south of the 1956 relocation. As a result, 1,742 feet of the original 1,851 feet of pipe from the 1956 relocation project, including the rupture location, remained in operation. In PG&E's records, this segment is known as Segment 180.
